**KAUAI**  
HOME INSPECTION  
SERVICES

**1234 Kii'awa Pl., Kapaa, HI 96746**  
**Inspection prepared for: Bill & Karen Sample**  
**Real Estate Agent: Don Corleone - La Familia Realty**

**Date of Inspection: 2/3/2016 Time: 9:30 AM**

**Inspector: Michael J Lagana**  
**License # NACHI13121220**  
**Kapaa, HI 96746**

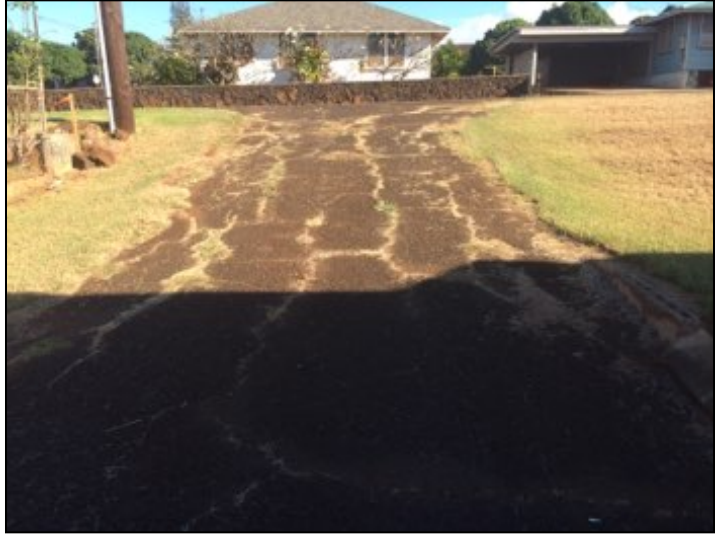
- Moderate cracks and damage at driveway were observed.

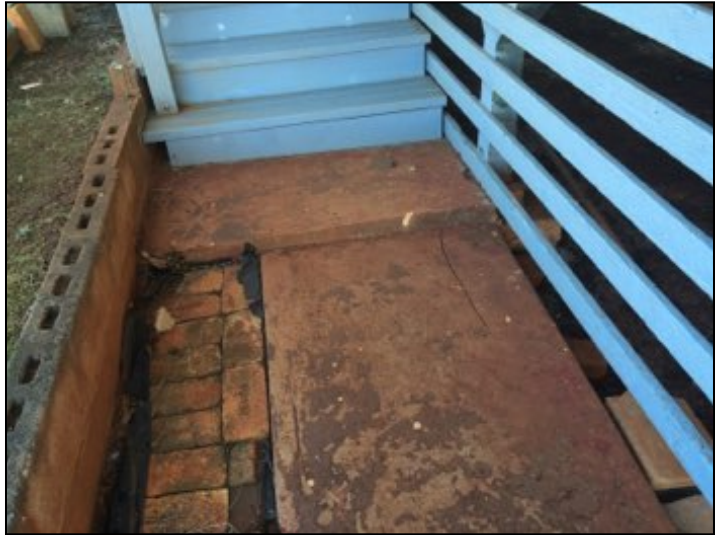
- Moderate cracks and damage to walkway were observed.

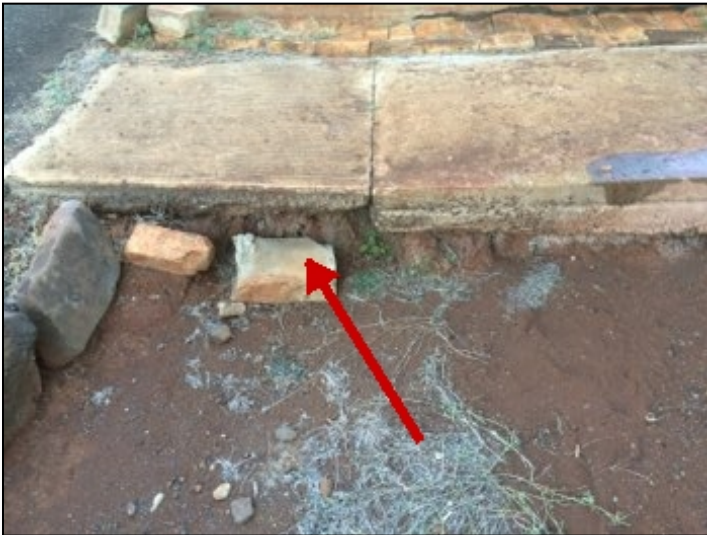
Soil subsidence at front walkway.

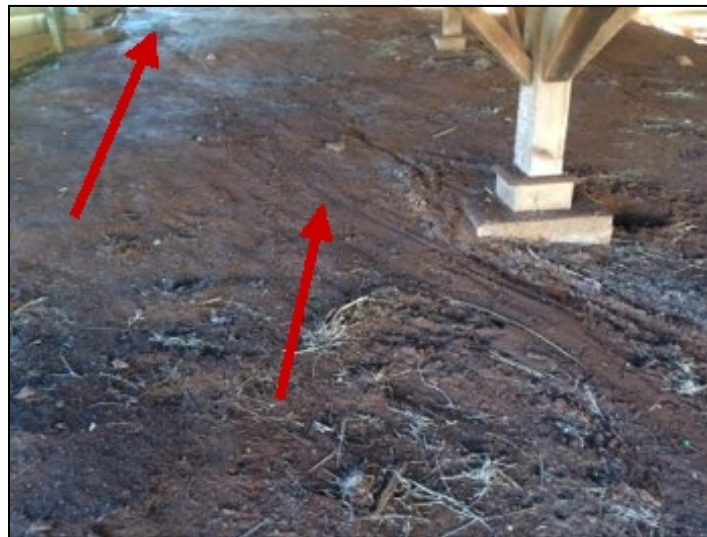
- The grading is improperly sloped towards the foundation. Moisture and evidence of water flow at the foundation crawlspace.

Evidence of moisture from poor drainage.

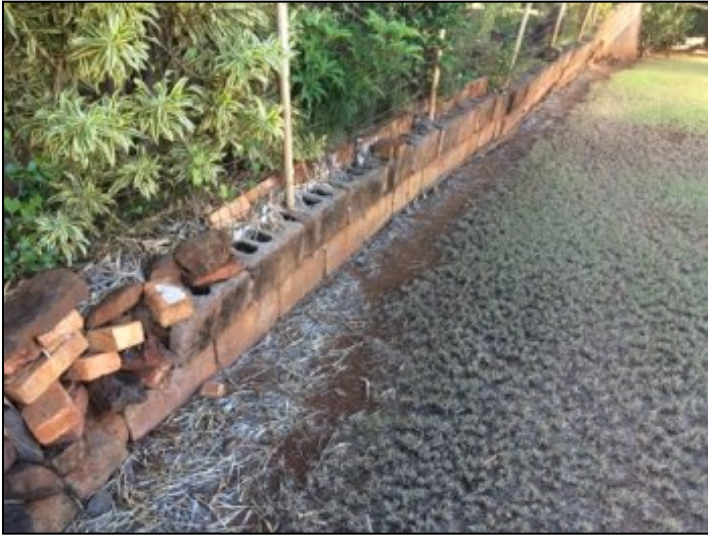
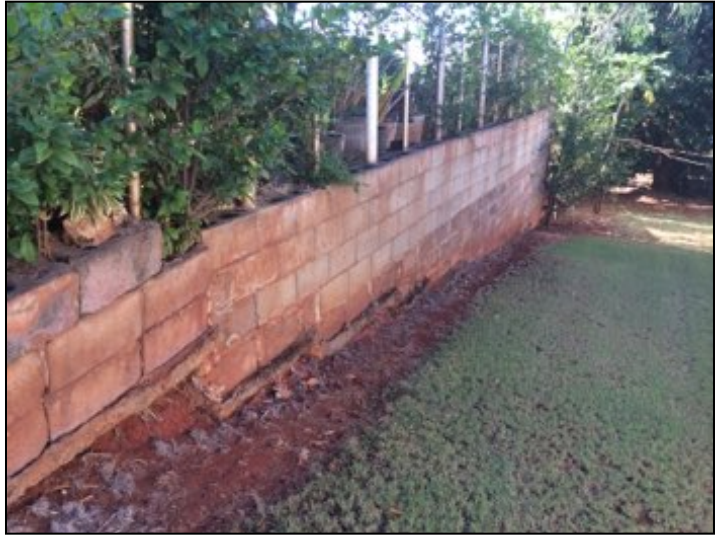
- Lower retaining wall towards the front of the property is poorly constructed and leaning.
- Rear section of retaining wall has moderate defects and damages, appears functional.

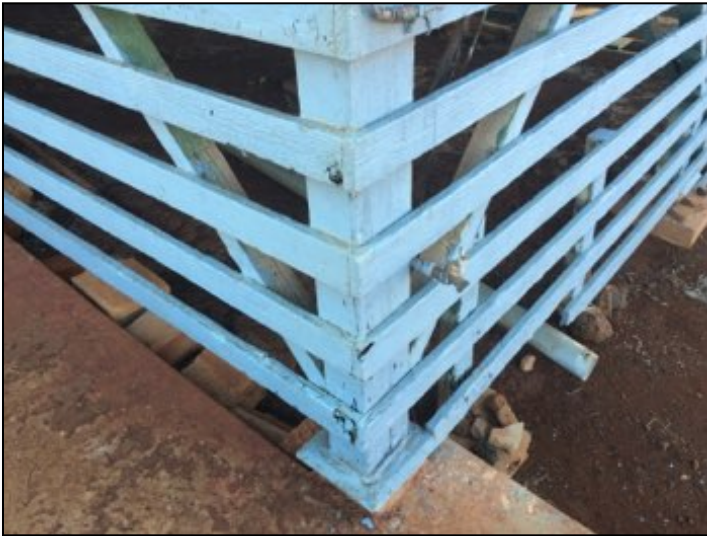
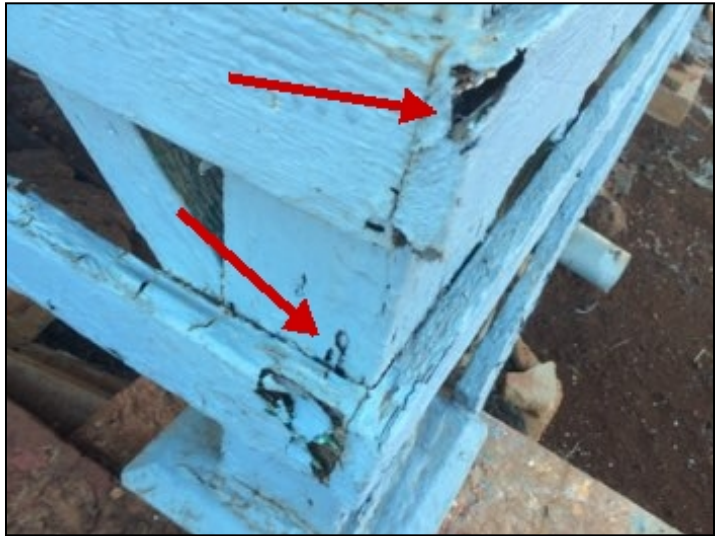
- Wear and tear, termite damage to foundation skirting.
- Termite damage was observed to a couple wood foundation posts. Contact a licensed general contractor to evaluate and make recommendations.

Significant termite damage to skirting and foundation post at the front of home.

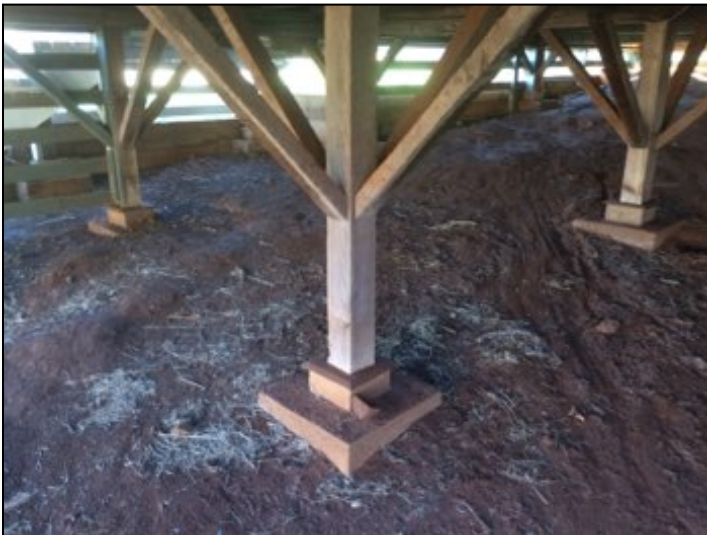
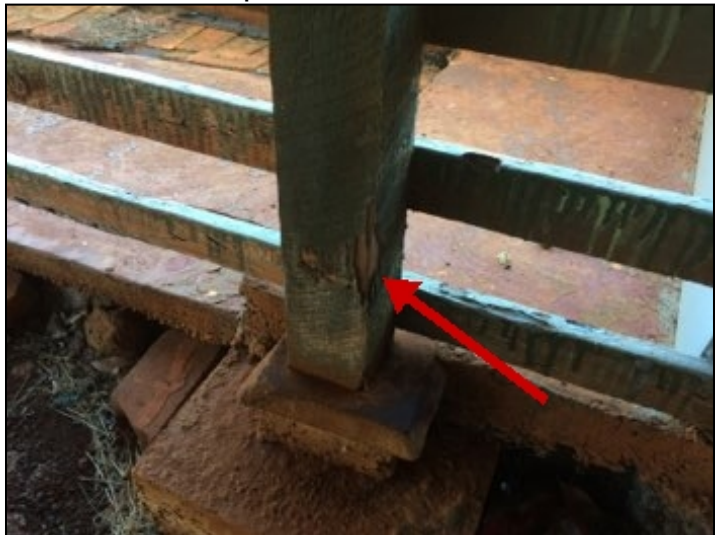
Termite damage.

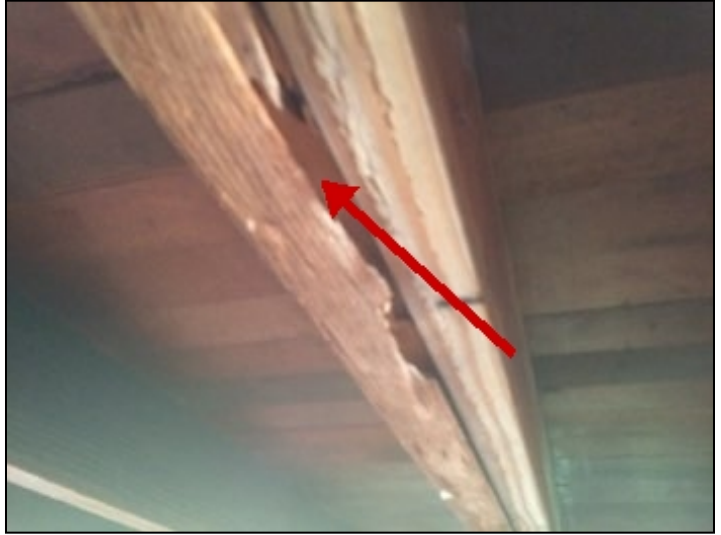
- Evidence of termite damage and repairs were observed at floor system. Contact a licensed general contractor to evaluate.

Termite damage and evidence of repairs.

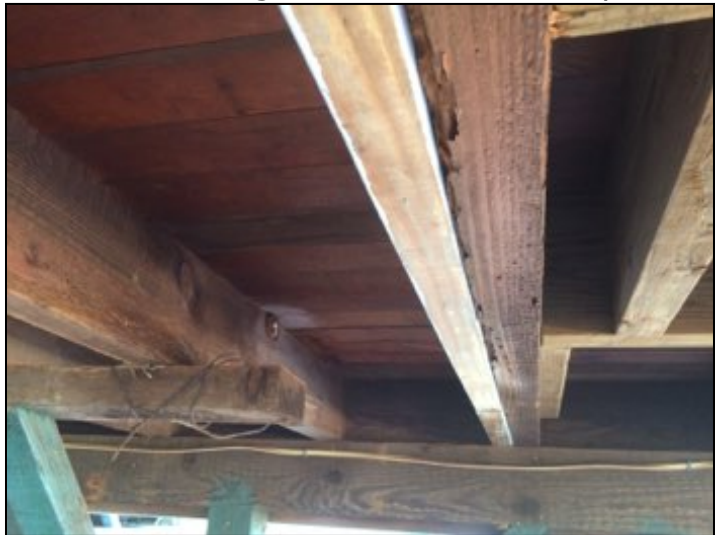
Termite damage and evidence of repairs.

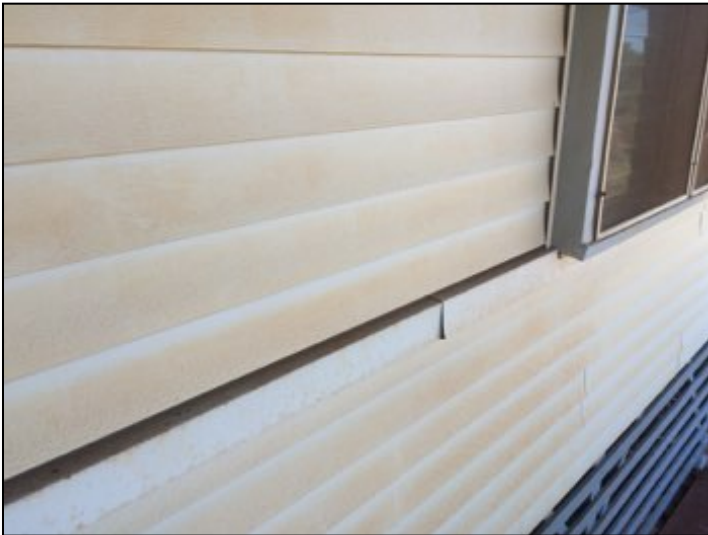
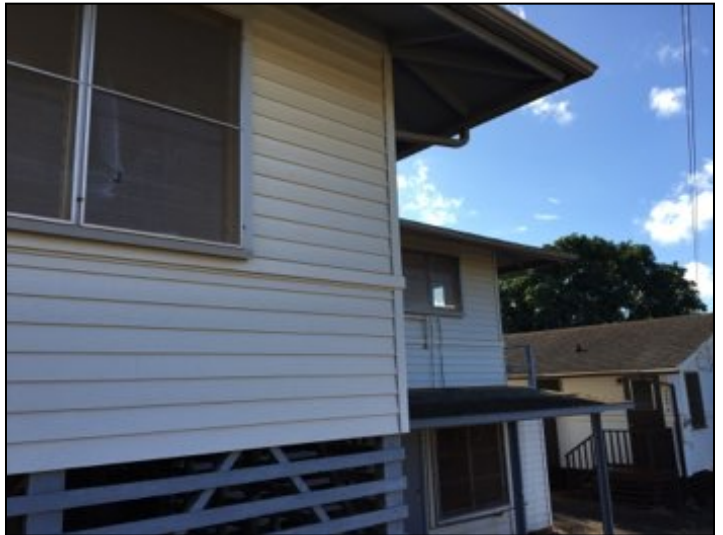
- Minor defects and damages were observed.

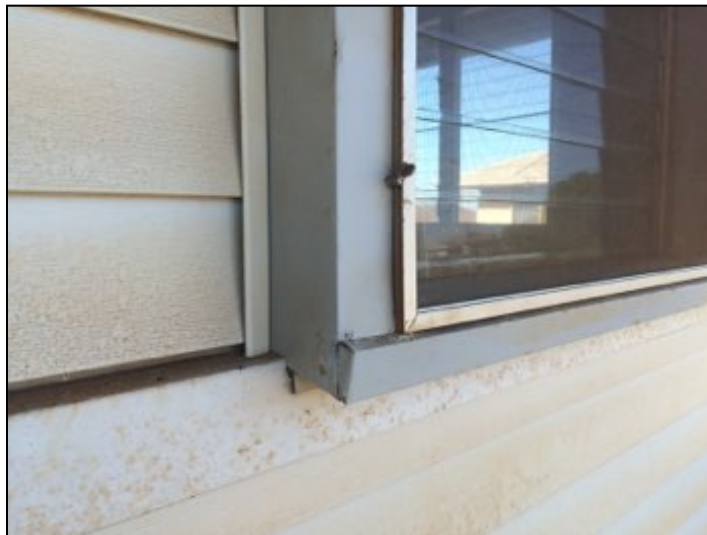
- Minor defects and damages were observed.

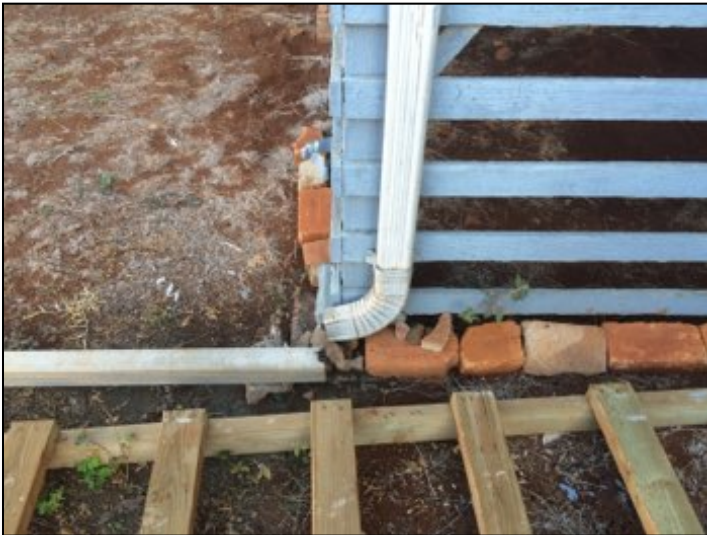
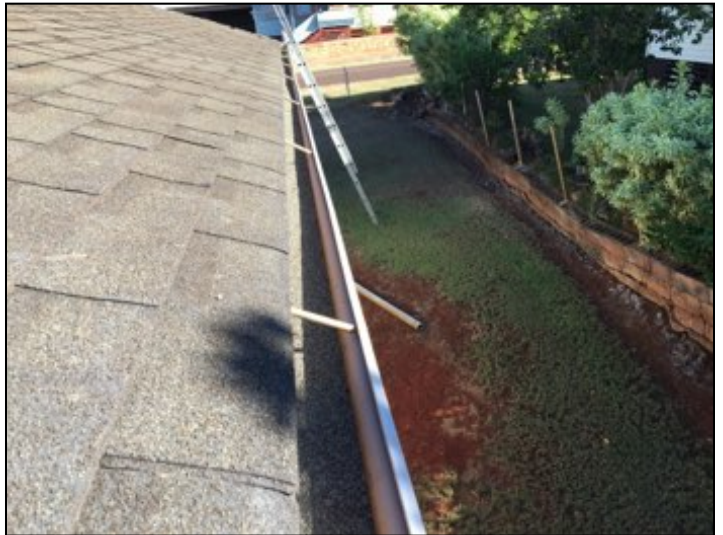
- Damaged or missing components were observed to rain gutters.
- Remove debris from gutters to ensure proper function.
- Repair rain gutter down spouts to provide proper drainage.

Missing/damaged components.

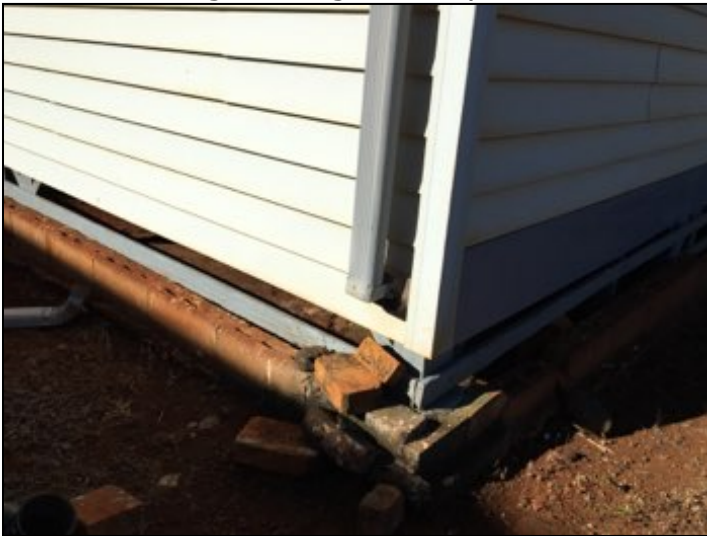
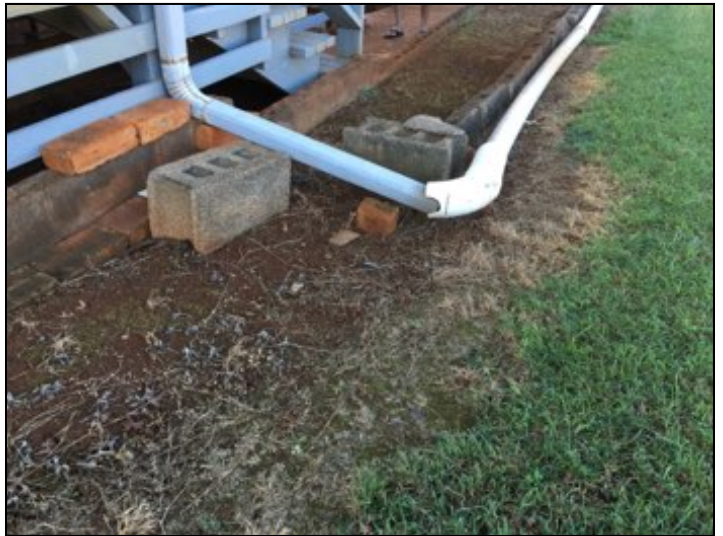
Rain gutter downspout missing components.

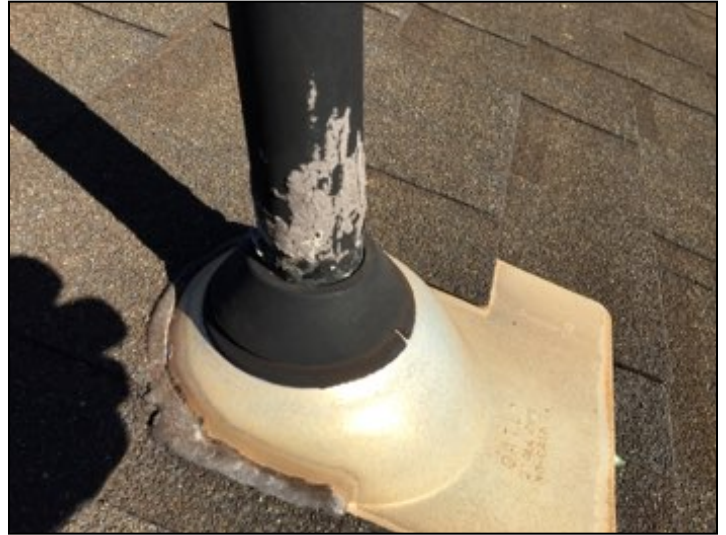
Deteriorated rubber gaskets at plumbing vents.

- Minor damage was observed to roof.
- Damaged rubber components at plumbing roof vents.
- Failing sealant at plumbing vents.
- Contact a licensed roofing contractor to evaluate.

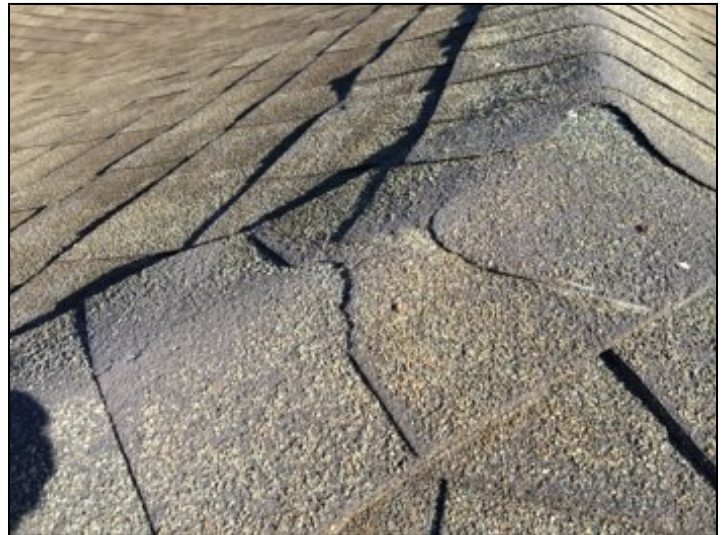
Damaged roof shingles.

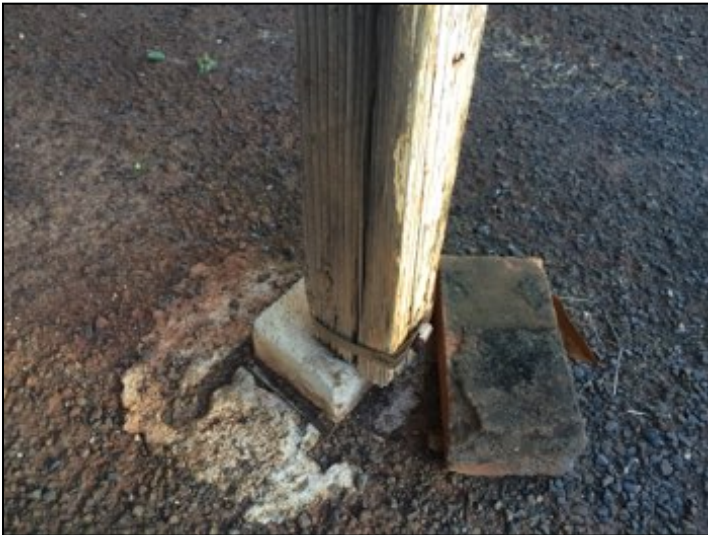
- Significant damage/ improper construction. Posts not anchored, inadequate footings or piers, termite damage and improper repairs. Contact a licensed general contractor to make recommendations.

Significant damage/ improper construction.

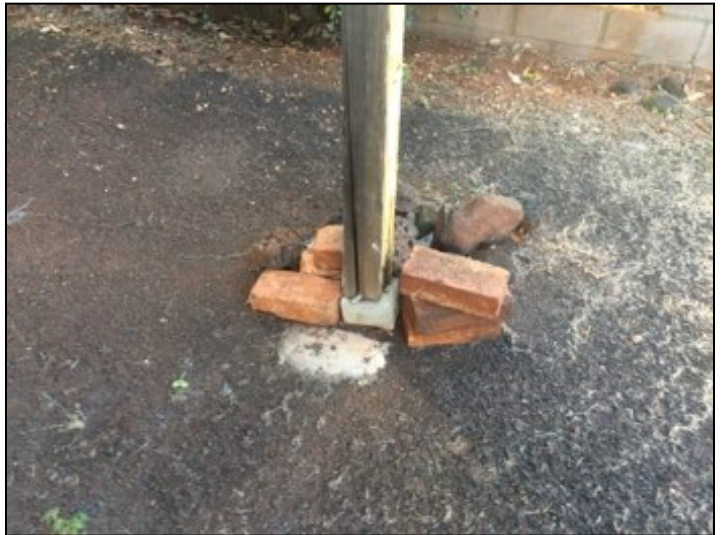
Significant damage/ improper construction.

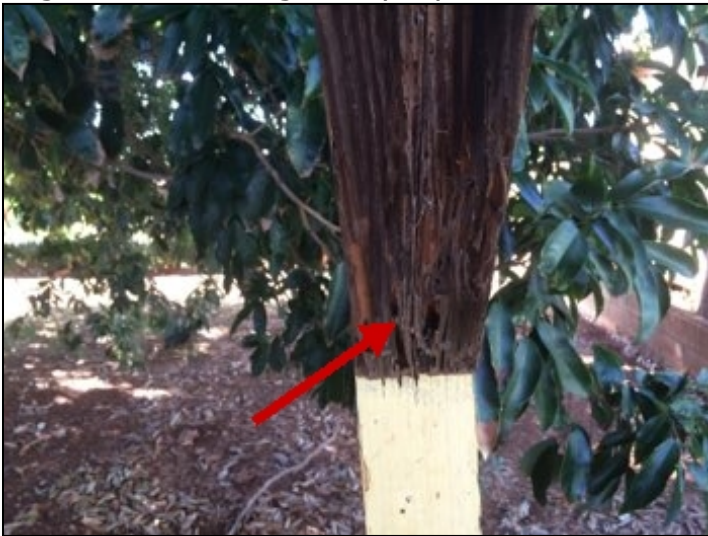
Termite damage.

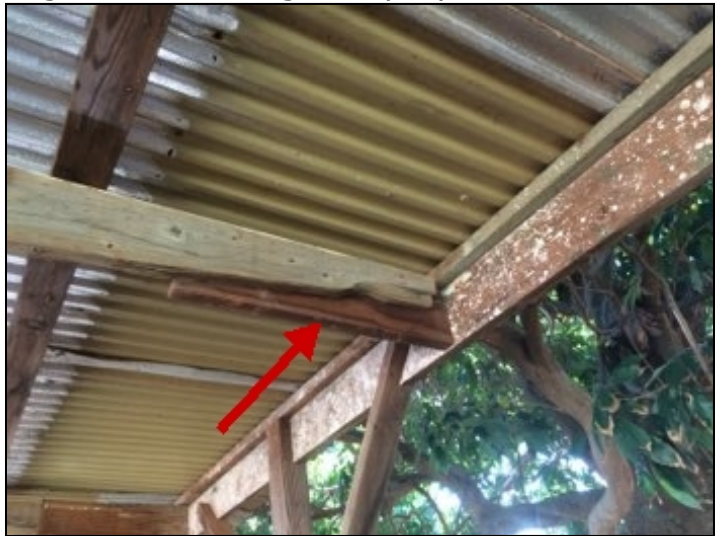
Improper repairs.

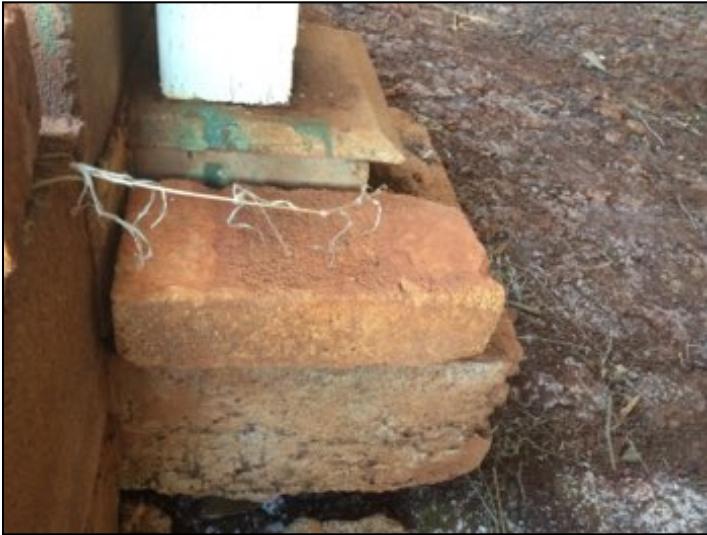
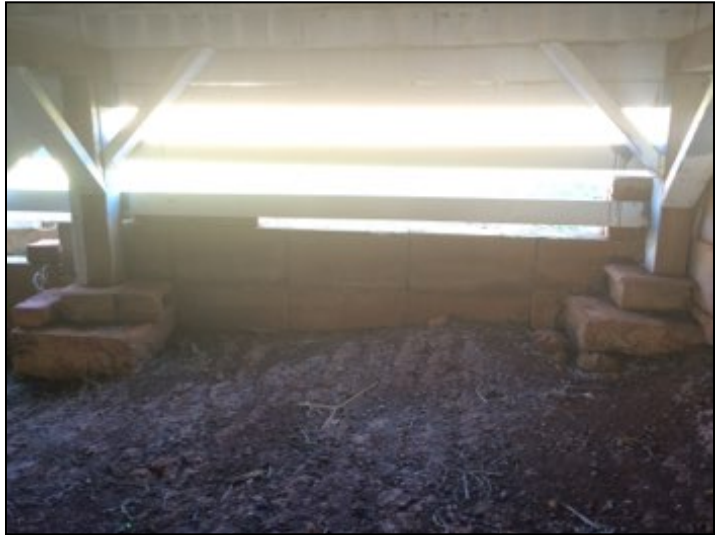
- Minor defects and damages.

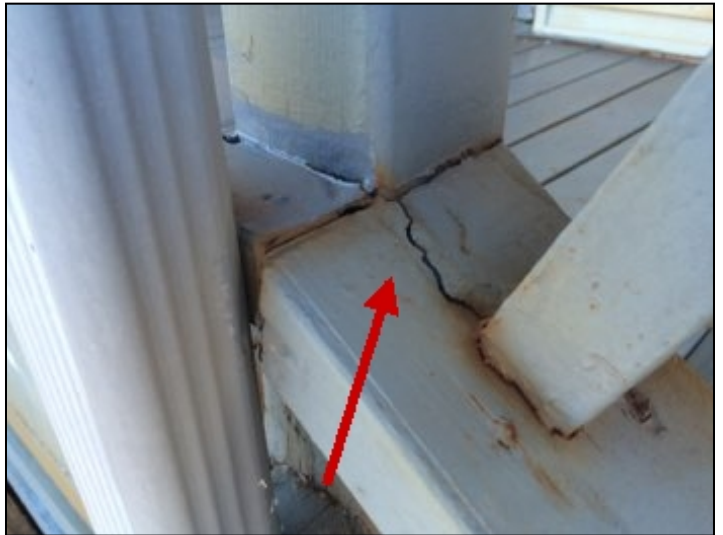
- Evidence of rot or damaged components at deck stair handrail.

Deterioration at entry stair handrail.

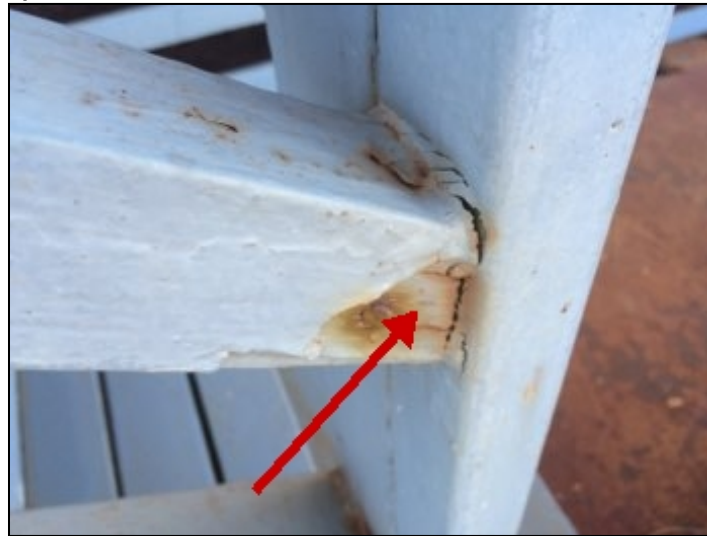
Deterioration at entry stair handrail.

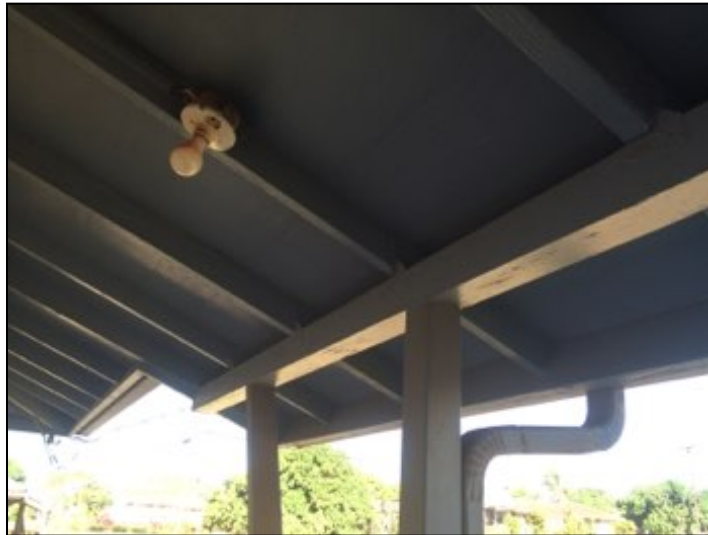
- Minor defects and damages.

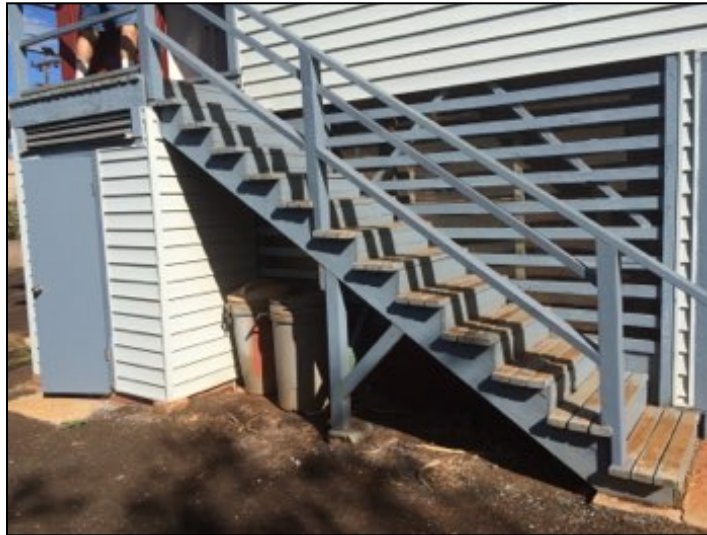
- Minor defects and damages.

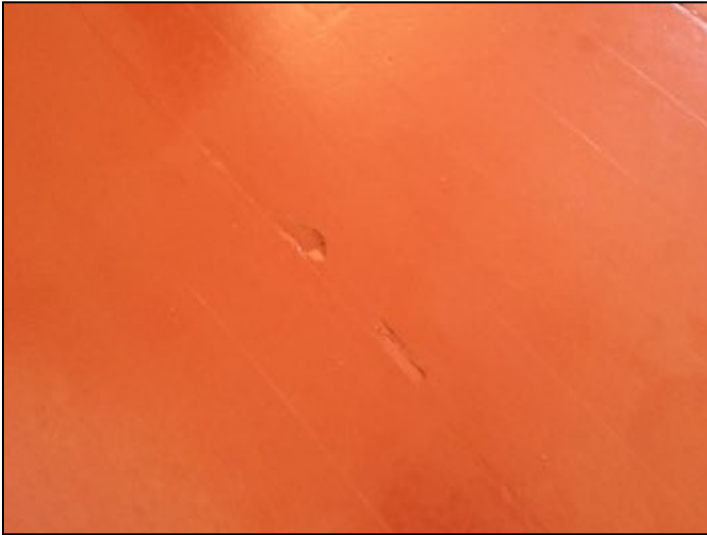
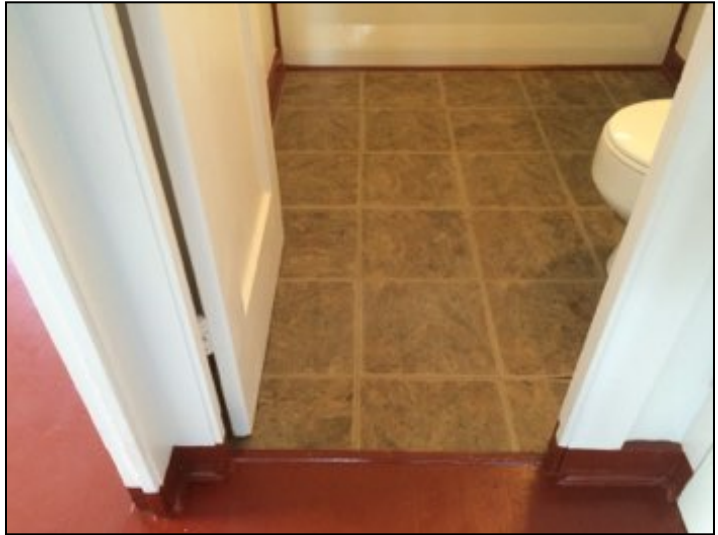
- Termite damage was observed at a couple locations.

Termite damage at kitchen floor.

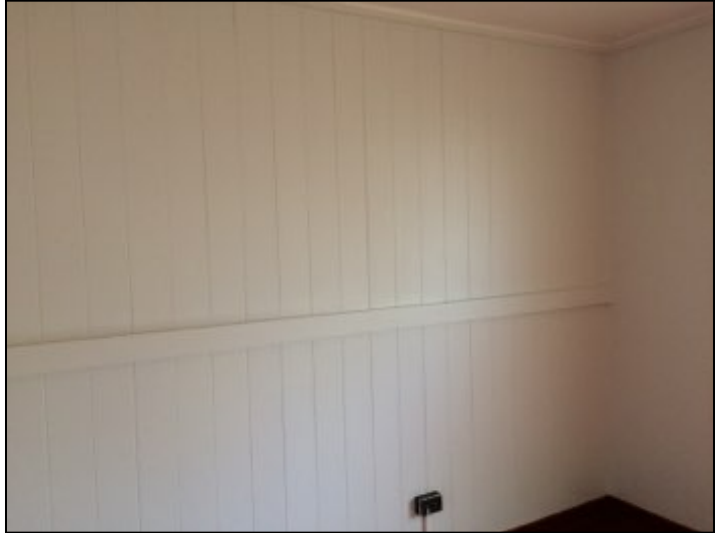
- Minor cosmetic defects and damages observed.

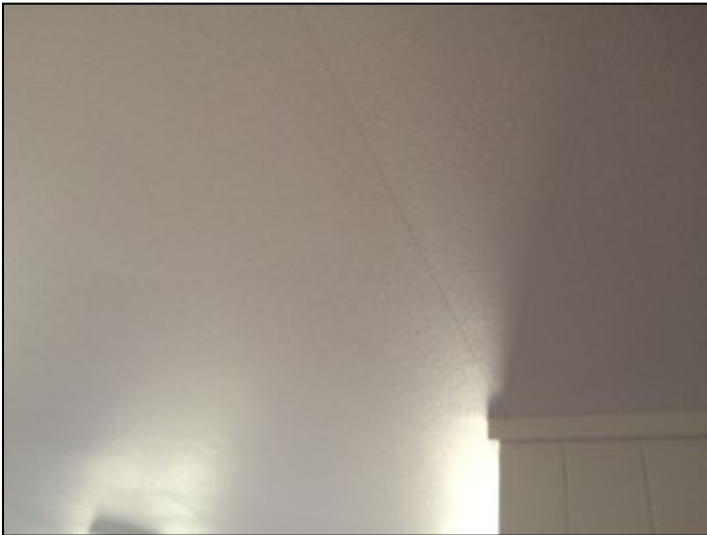
Minor defect at living room adjacent to kitchen.

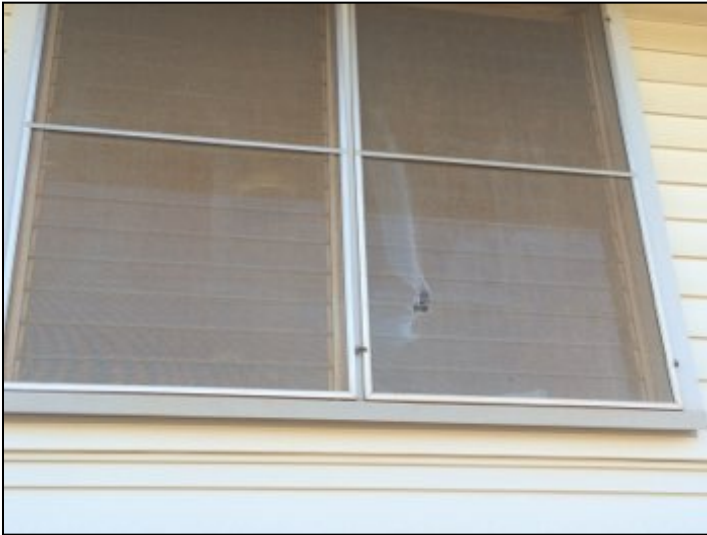
Damaged window screen west side of home.

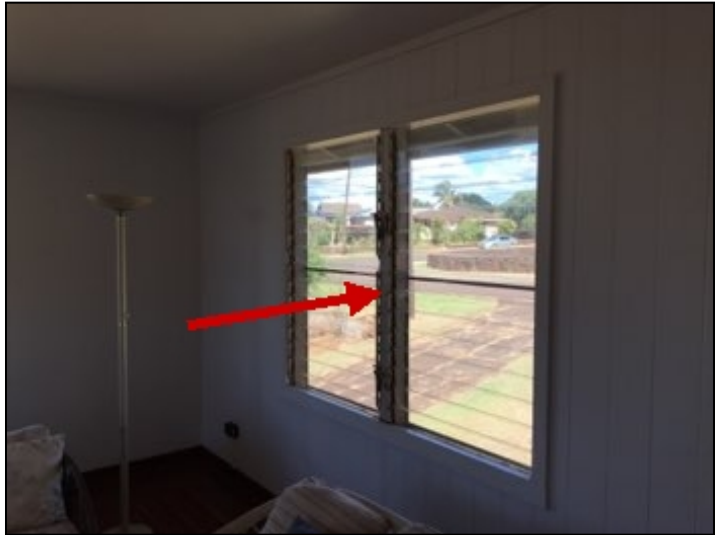
Termite damage at window frame.

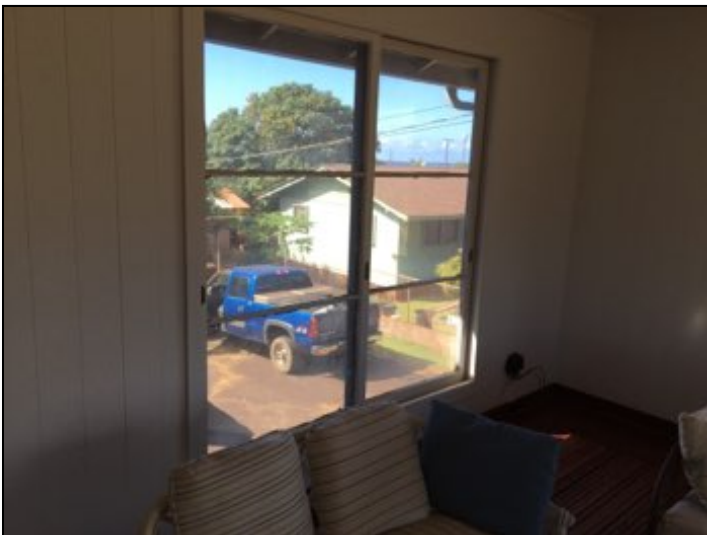
Living room window height does not meet current safety standards.

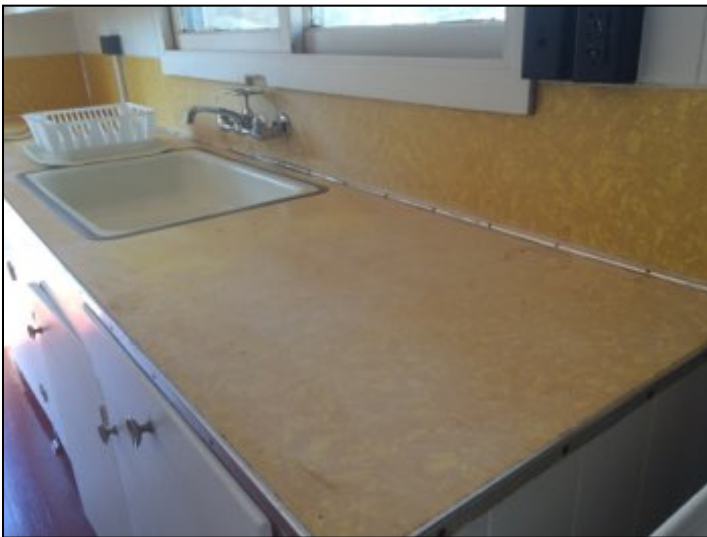
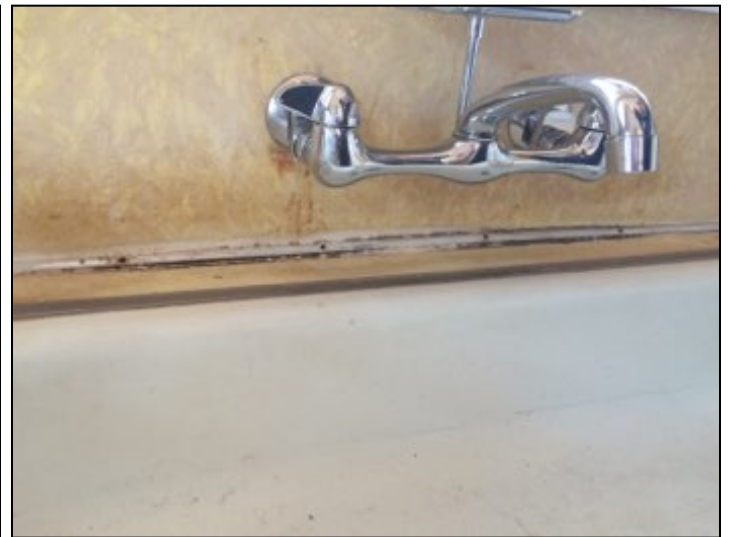
- Deteriorated sealant behind kitchen sink.
- Kitchen countertops were worn.

Deteriorated caulking at kitchen countertop.

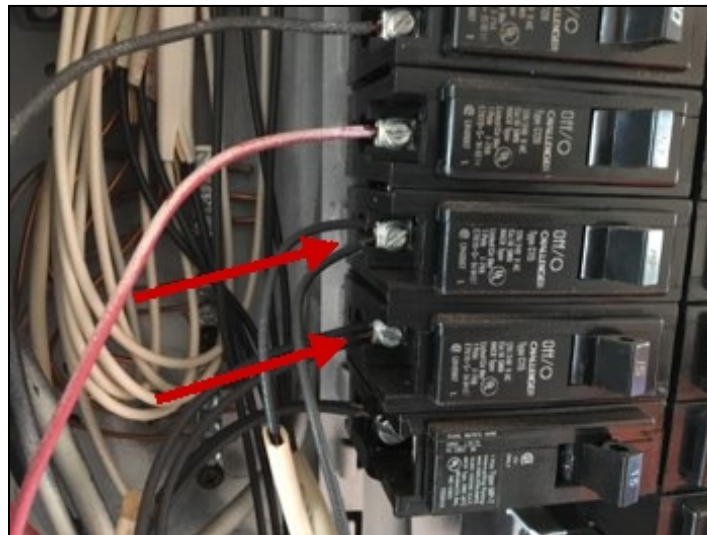
- Breakers in the "off" position are not turned on. Breaker to range and water heater not on at the time of inspection.
- Improper wiring was observed at main panel, "double tapping" or 2 circuits into 1 breaker. Contact a licensed electrical contractor to evaluate and repair.

Improper wiring - double tapping.

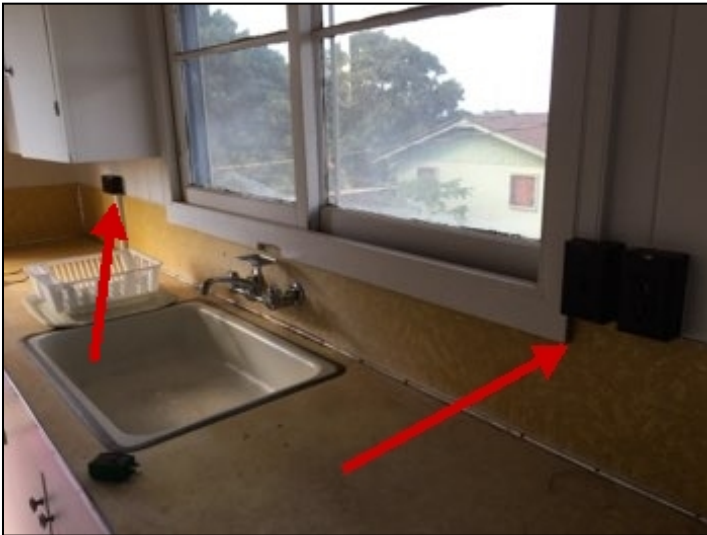
- Receptacles at kitchen counter not GFI protected.
- Receptacle at bathroom did not respond to test. Contact a licensed electrical contractor to provide and repair GFI receptacles at required locations.

No GFI protected receptacles at kitchen sink.

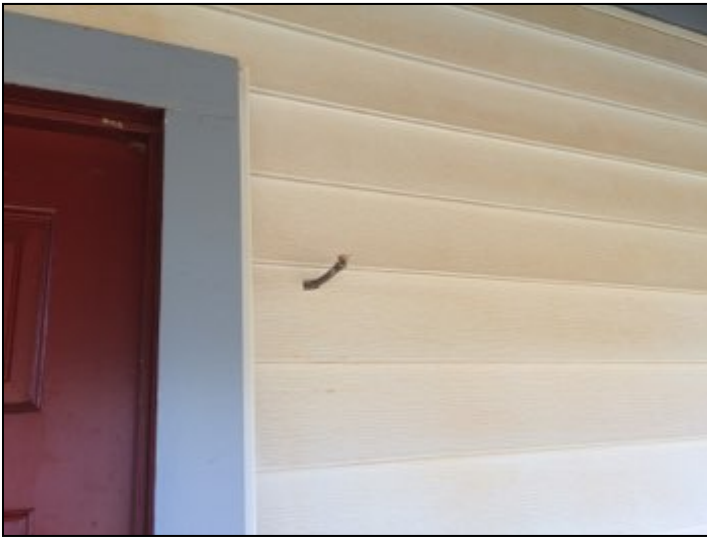
Missing light fixture, bare wires at main entry door.

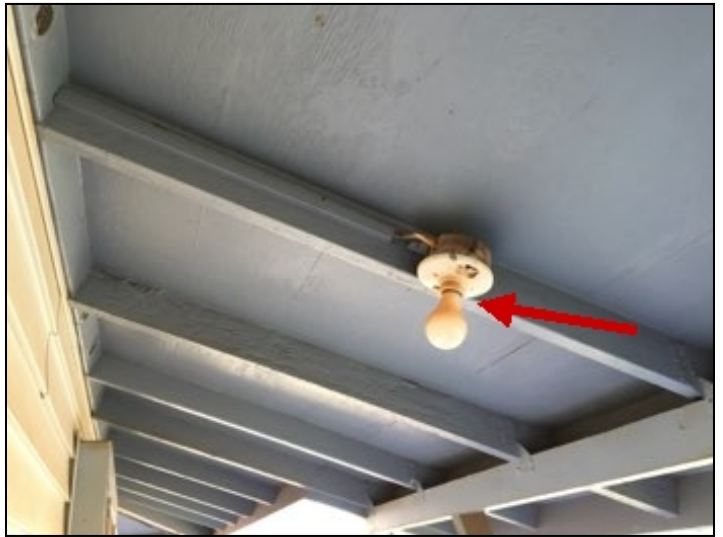
Light bulb arcing at socket.

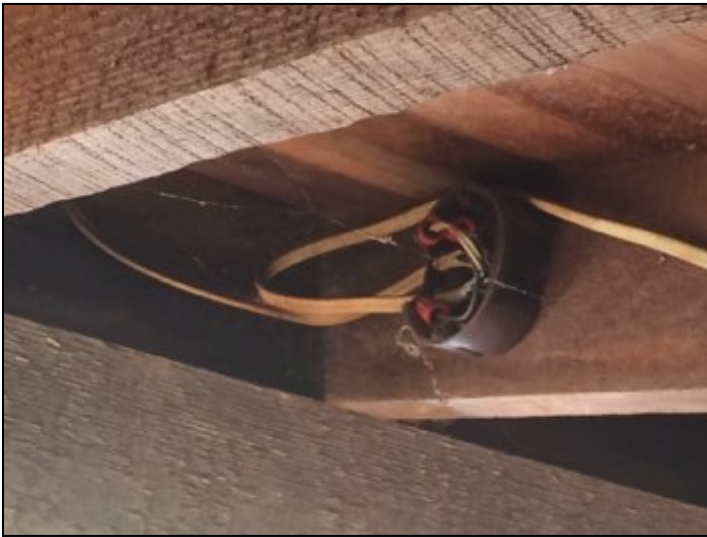
- Missing covers at junction boxes at foundation crawl space.
- Exposed romex wiring at lower storage room.

Open electrical junction boxes at foundation.

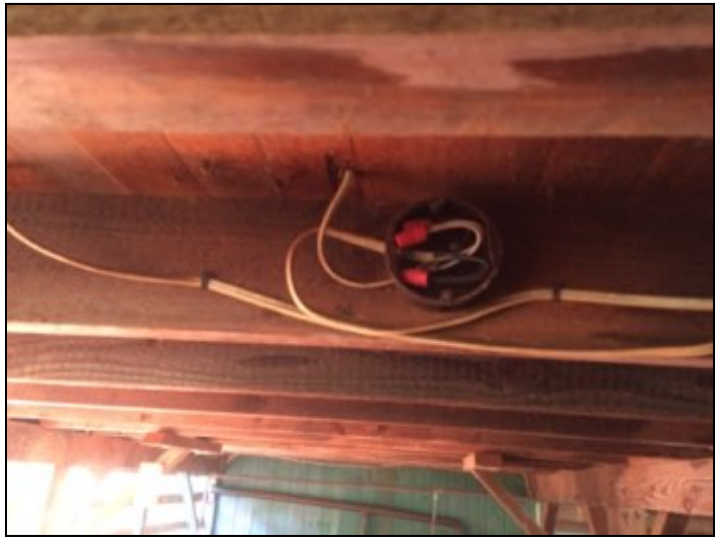
Open electrical junction boxes at foundation.

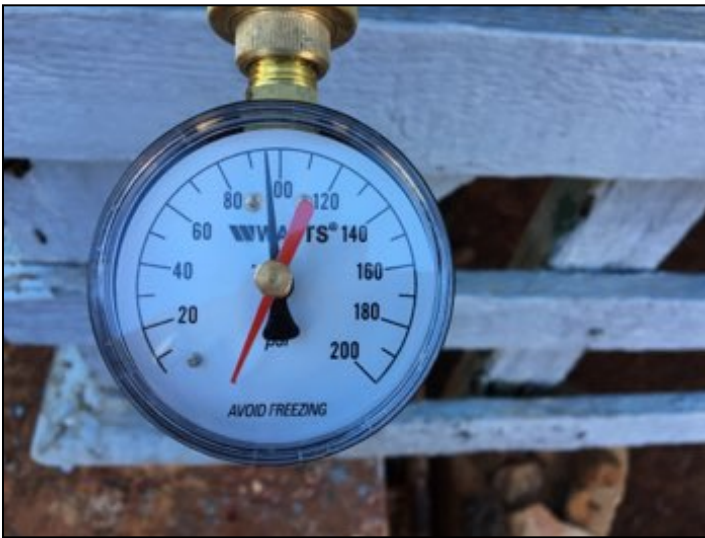
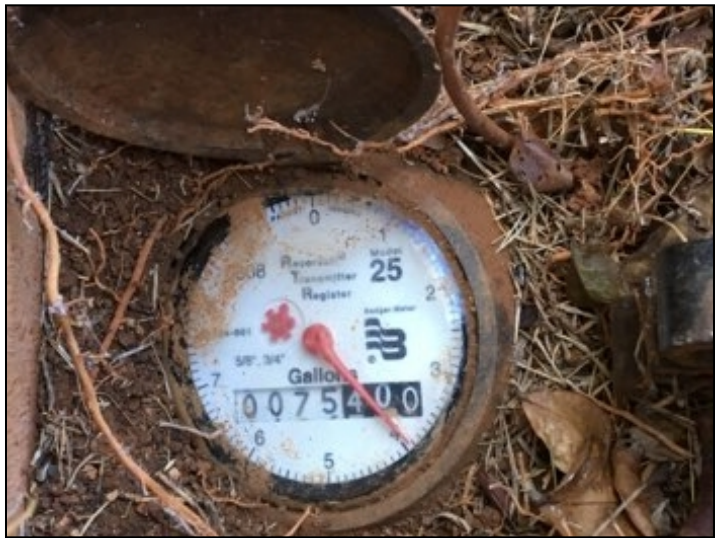
- Water pressure was tested a hose bib and observed to be over 80 psi. 40-80 is considered normal. Excessive water pressure puts stress on soldered plumbing joints and plumbing valves and may cause damage. Contact a licensed plumbing contractor to make recommendations.
- Galvanized plumbing pipes joined to copper pipes, causing galvanic corrosion. Contact a licensed plumbing contractor to evaluate supply lines and make recommendations.
- Some plumbing pipes at crawlspace were not properly secured.

Water meter registers water use with no fixtures in use.

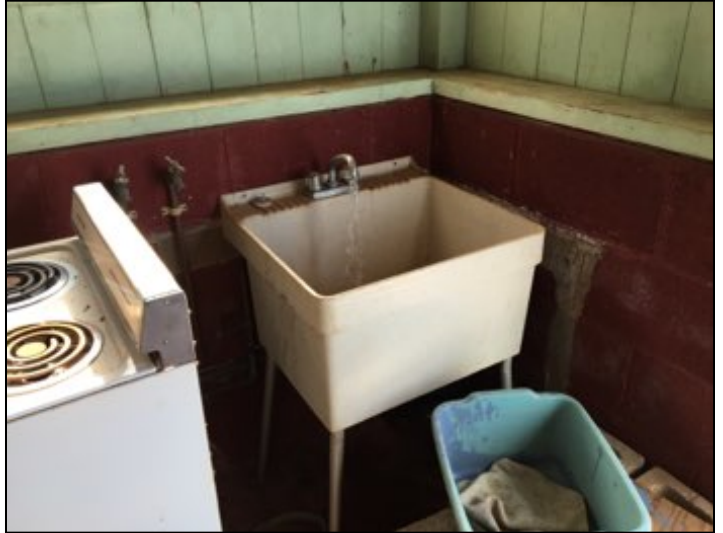
- Provide stoppers at sinks where missing or not functional.

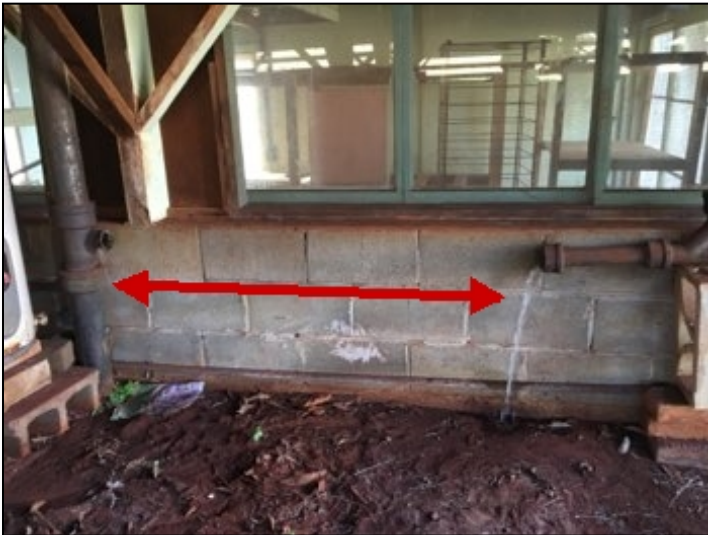
- Drain pipes consist of ABS plastic and metal.
- Leaking drain trap at plastic utility sink.
- Missing cast iron drain pipe at crawlspace. Contact a licensed plumbing contractor to evaluate drain system and make repairs.

Missing section of plumbing drain pipe.

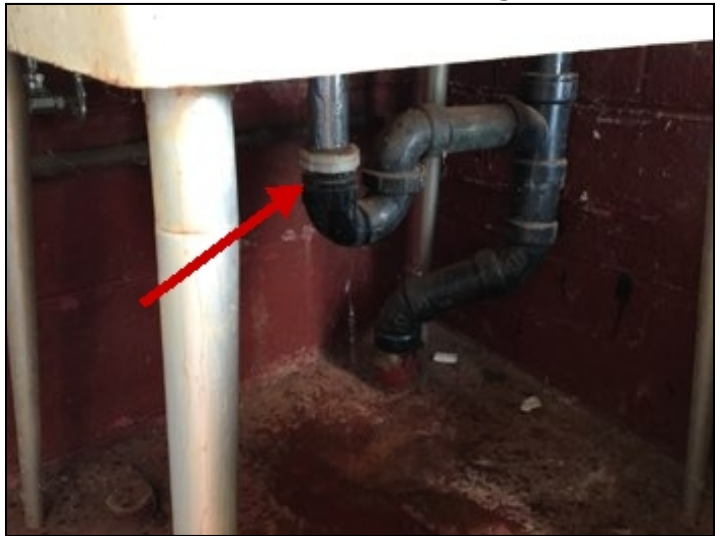
Lower level utility sink leaks at trap.

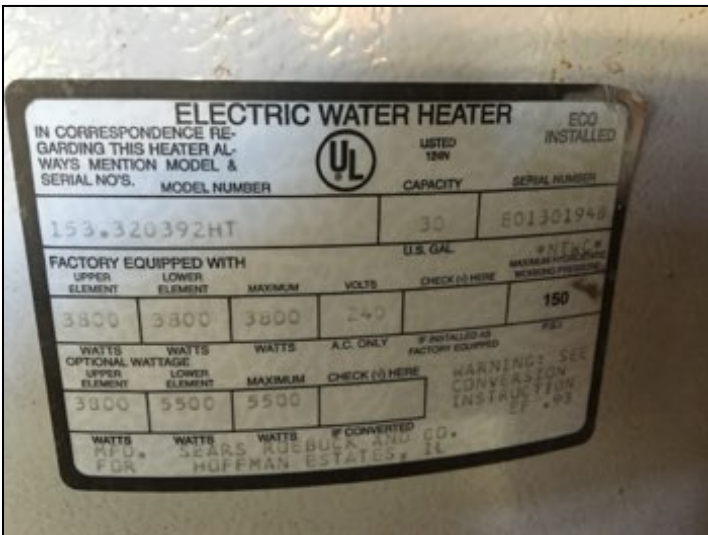
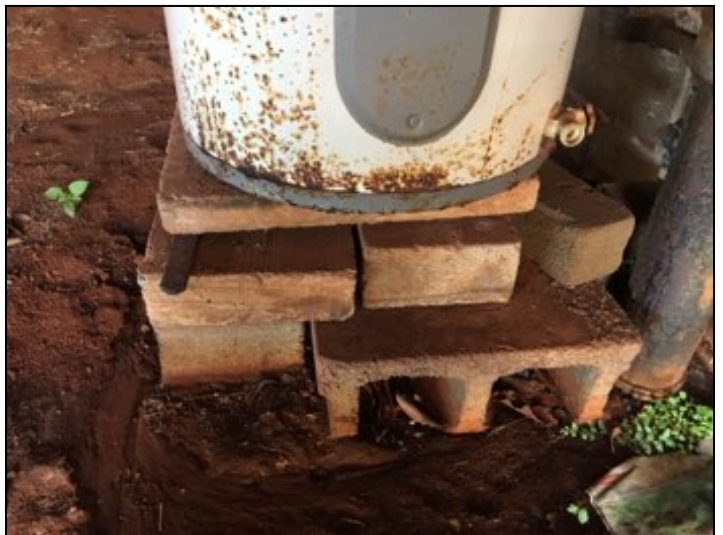
- Improper platform for water heater.
- Significant corrosion to water heater base.
- Missing pipe extension for TPR valve.

Significant rust at water heater base.  
Improper water heater platform.

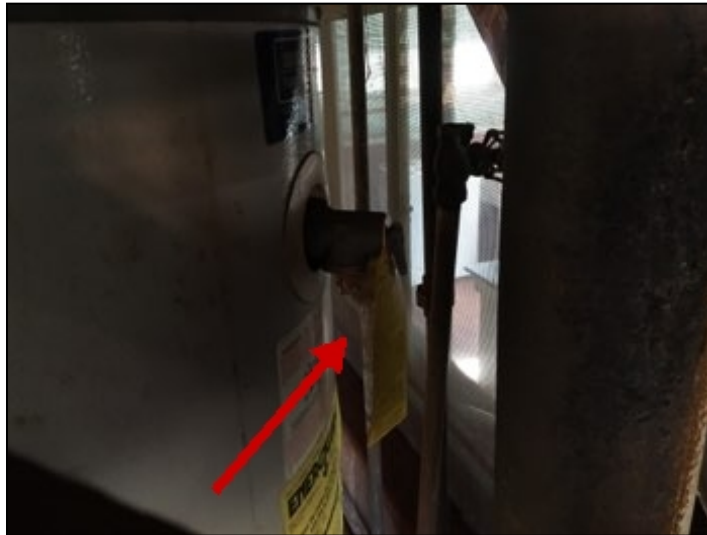
Missing TPR valve extension.
