**KAUAI**  
HOME INSPECTION  
SERVICES

**1234 Kii'awa Pl., Kapaa, HI 96746**  
**Inspection prepared for: Bill & Karen Sample**  
**Real Estate Agent: Don Corleone - La Familia Realty**

**Date of Inspection: 2/3/2016 Time: 9:30 AM**

**Inspector: Michael J Lagana**  
**License # NACHI13121220**  
**Kapaa, HI 96746**

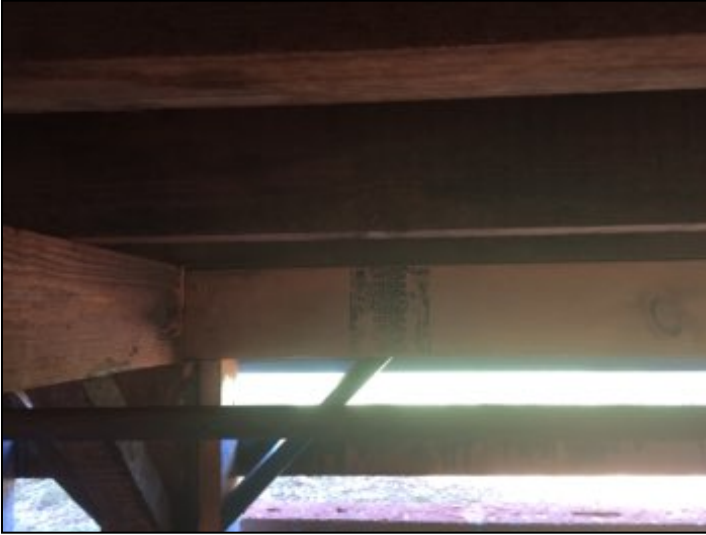
- Evidence of termite damage and repairs were observed at floor system. Contact a licensed general contractor to evaluate.

Evidence of repairs at foundation.

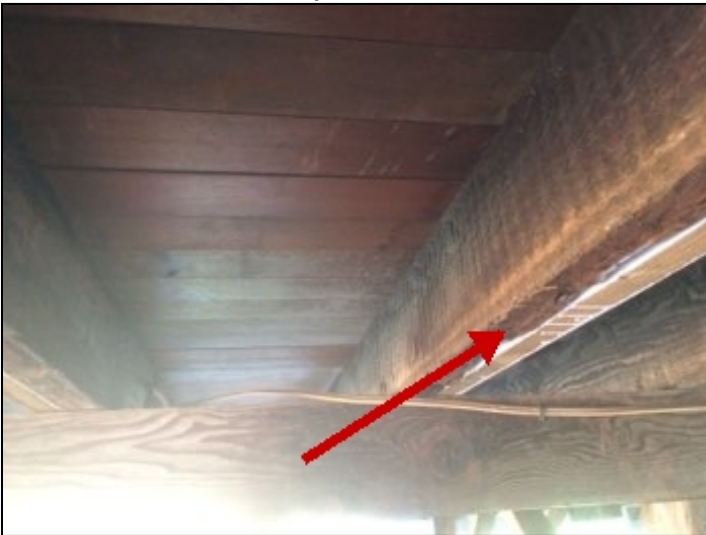
Termite damage and evidence of repairs.

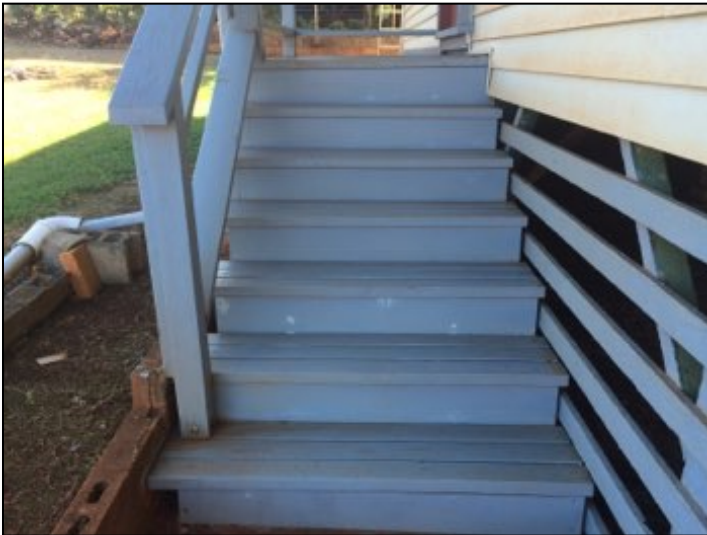
Front entry stairs.

- Evidence of rot or damaged components at deck stair handrail.

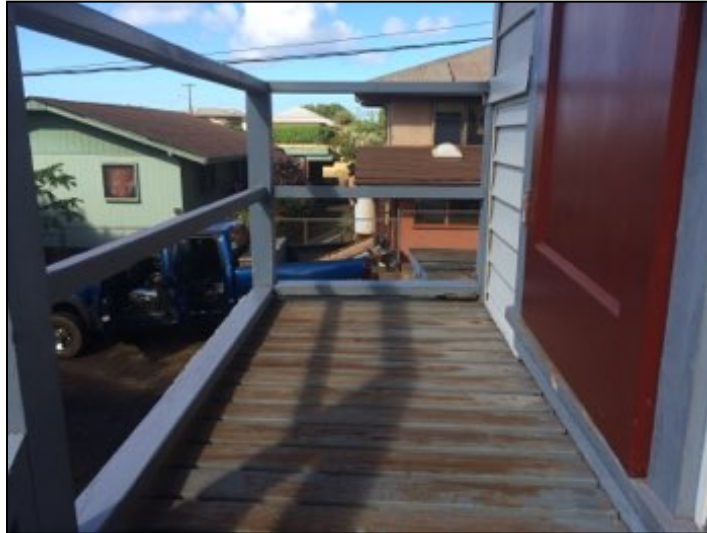
Safety rail does not meet current safety standards.

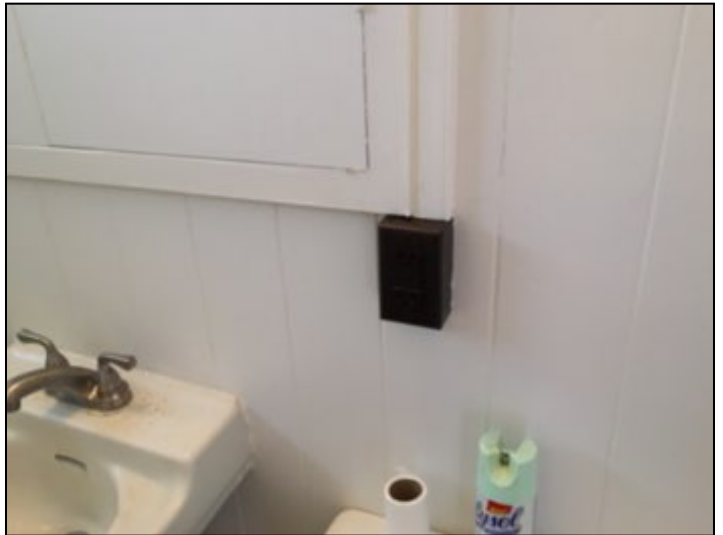
GFI outlet in bathroom did not respond to test.

- Receptacles at kitchen counter not GFI protected.
- Receptacle at bathroom did not respond to test. Contact a licensed electrical contractor to provide and repair GFI receptacles at required locations.

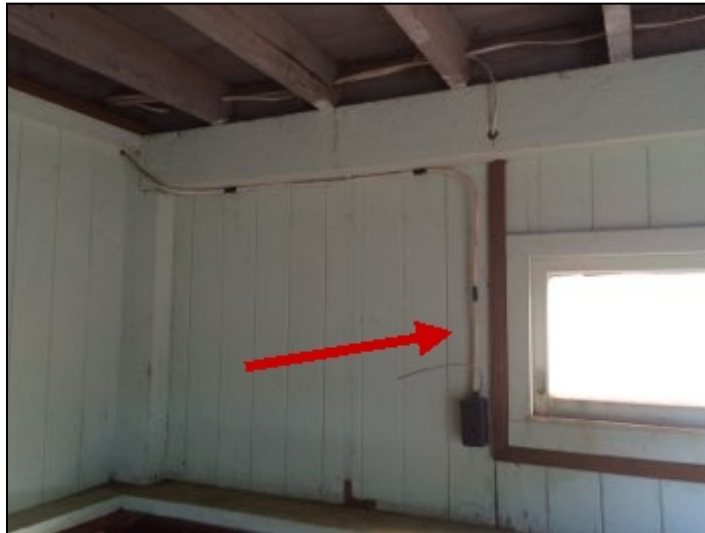
- Missing covers at junction boxes at foundation crawl space.
- Exposed romex wiring at lower storage room.

Exposed romex wires.

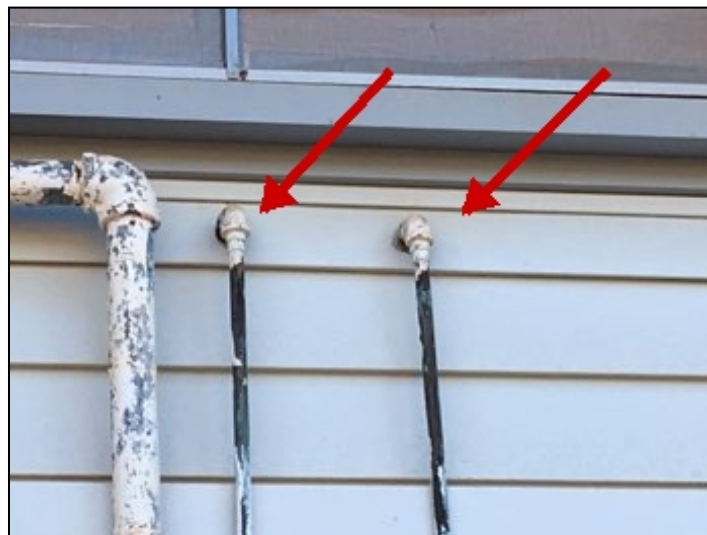
Galvanized pipe connected directly to copper pipe.
