**KAUAI**  
HOME INSPECTION  
SERVICES

**1234 Kii'awa Pl., Kapaa, HI 96746**  
**Inspection prepared for: Bill & Karen Sample**  
**Real Estate Agent: Don Corleone - La Familia Realty**

**Date of Inspection: 2/3/2016 Time: 9:30 AM**

**Inspector: Michael J Lagana**  
**License # NACHI13121220**  
**Kapaa, HI 96746**

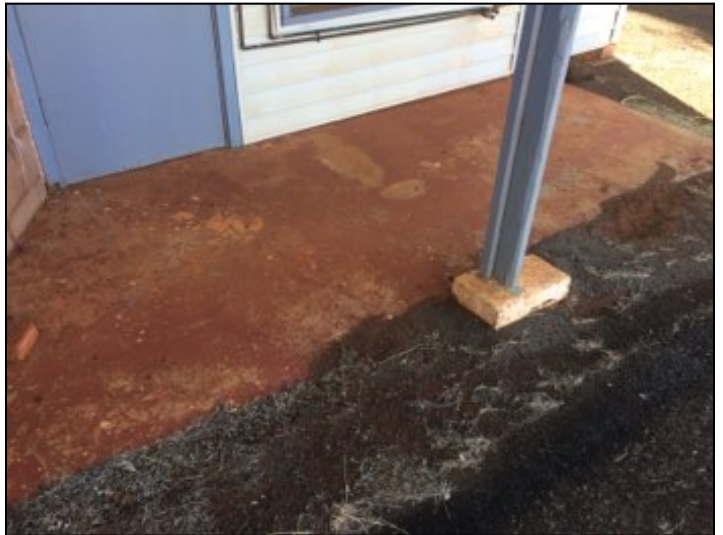
Soil subsidence at front walkway.

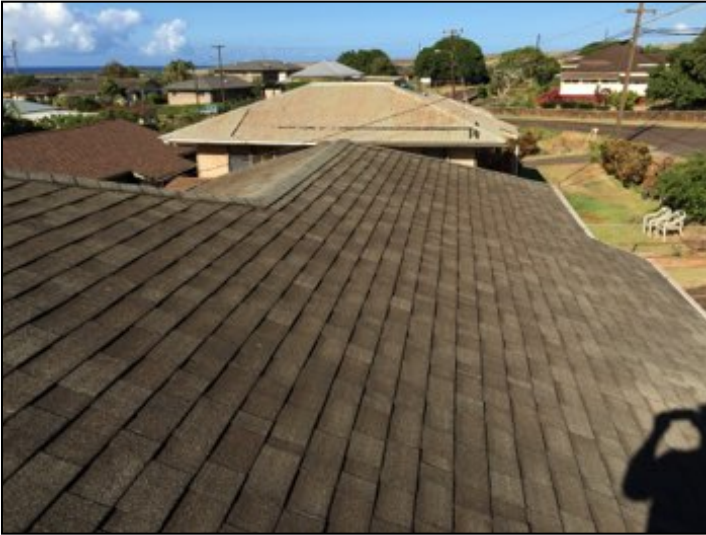
- Minor damage was observed to roof.
- Damaged rubber components at plumbing roof vents.
- Failing sealant at plumbing vents.
- Contact a licensed roofing contractor to evaluate.

Deteriorated rubber gaskets at plumbing vents.

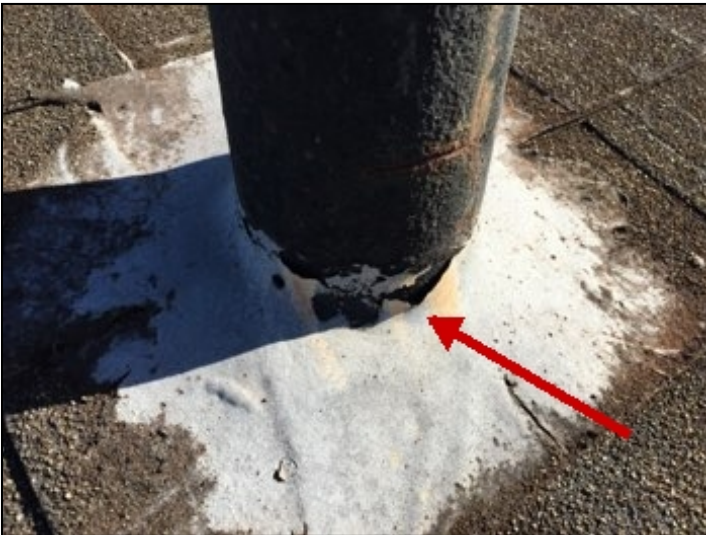
Deteriorated sealant.

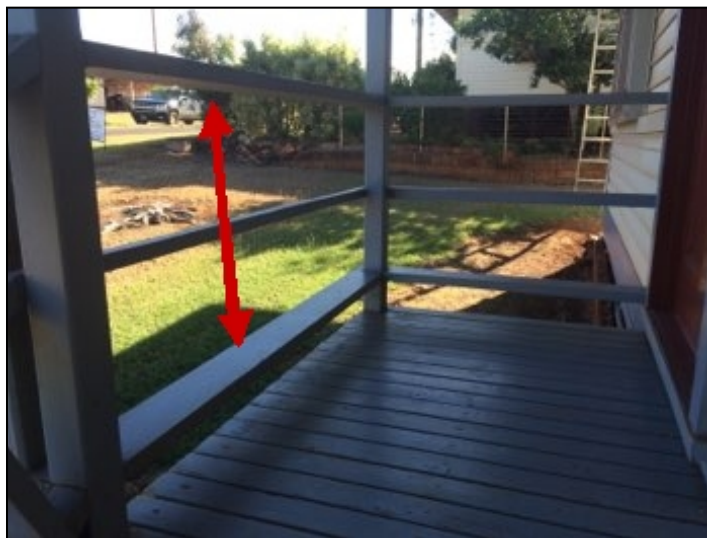
Safety rail does not meet current safety standards.

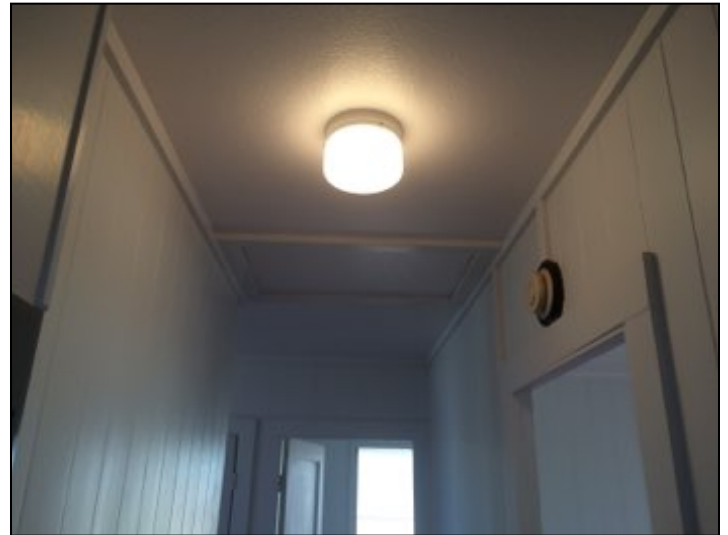
Minor defect at living room adjacent to kitchen.

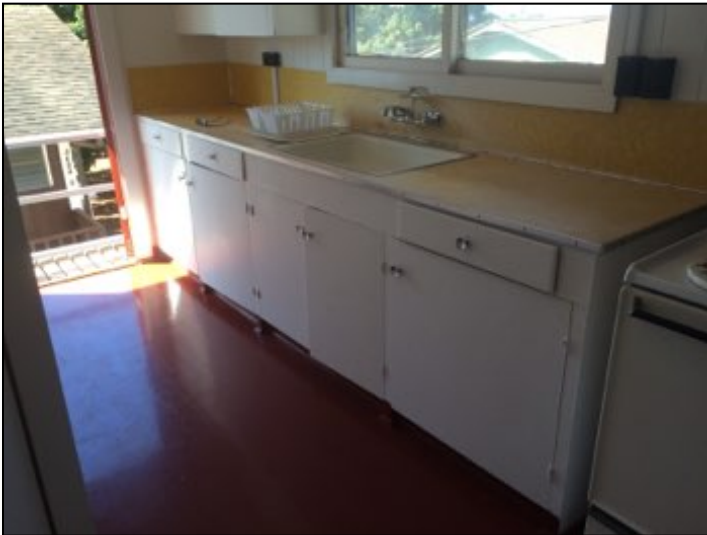
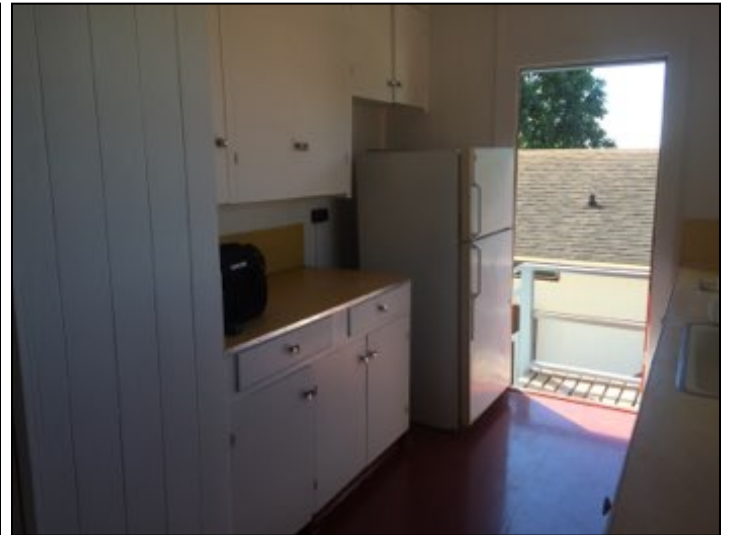
- Several doors and drawers in kitchen are misaligned, do not open or close properly.

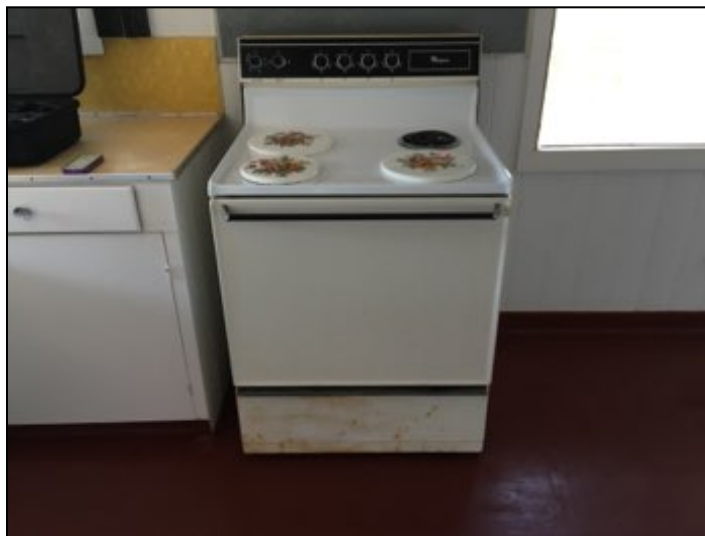
- Not operational.
- Anti tip device not present at range. Install device to prevent injuries.

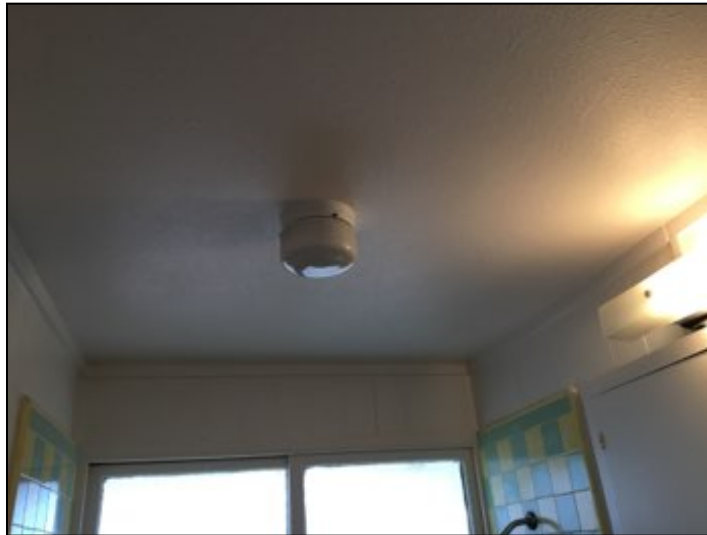
General room lighting fixture in bathroom not working possibly change lightbulb.

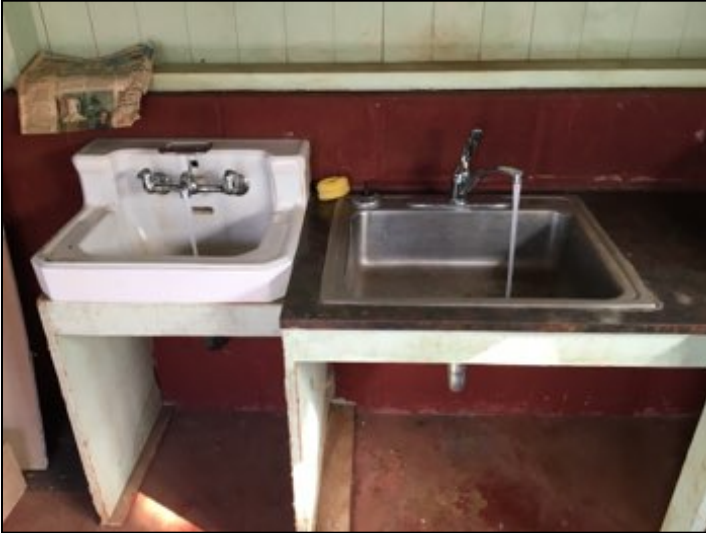
- Provide stoppers at sinks where missing or not functional.

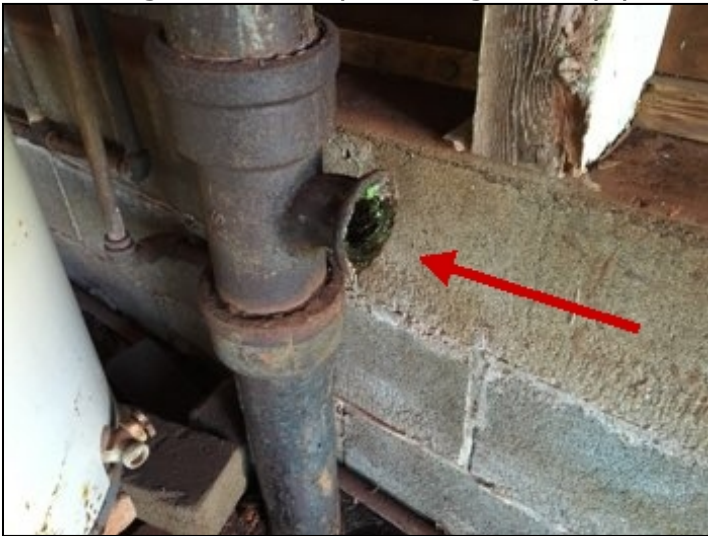
Toilet discharge.

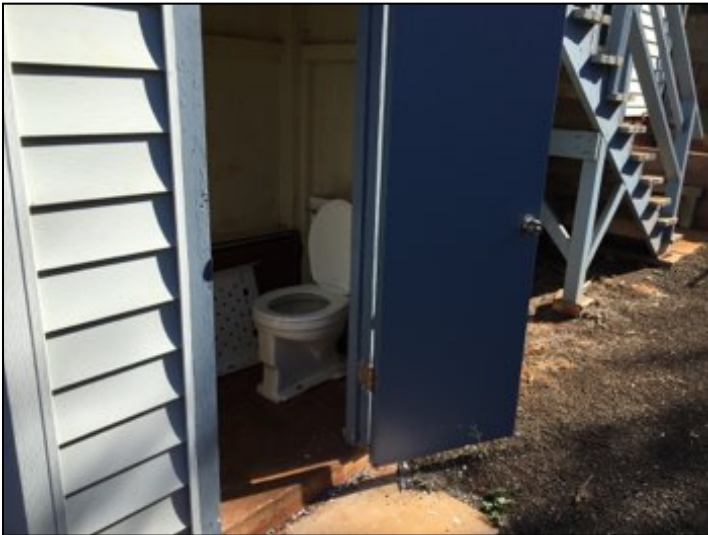
Exterior half-bath.

- Toilet was secure and functional.
